**Agnese Rudusāne, Māra Pakalne, Juris Pētersons**, LIFE REstore project, Nature Conservation Agency  
agnese.rudusane@daba.gov.lv

## AIM

To ascertain whether the reintroduction of the characteristic vegetation after peat extraction is possible, as well as to identify the most effective reintroduction method by planting various combinations of sphagnum and other mire plant species both on pre-prepared peat surface and without the surface preparation.

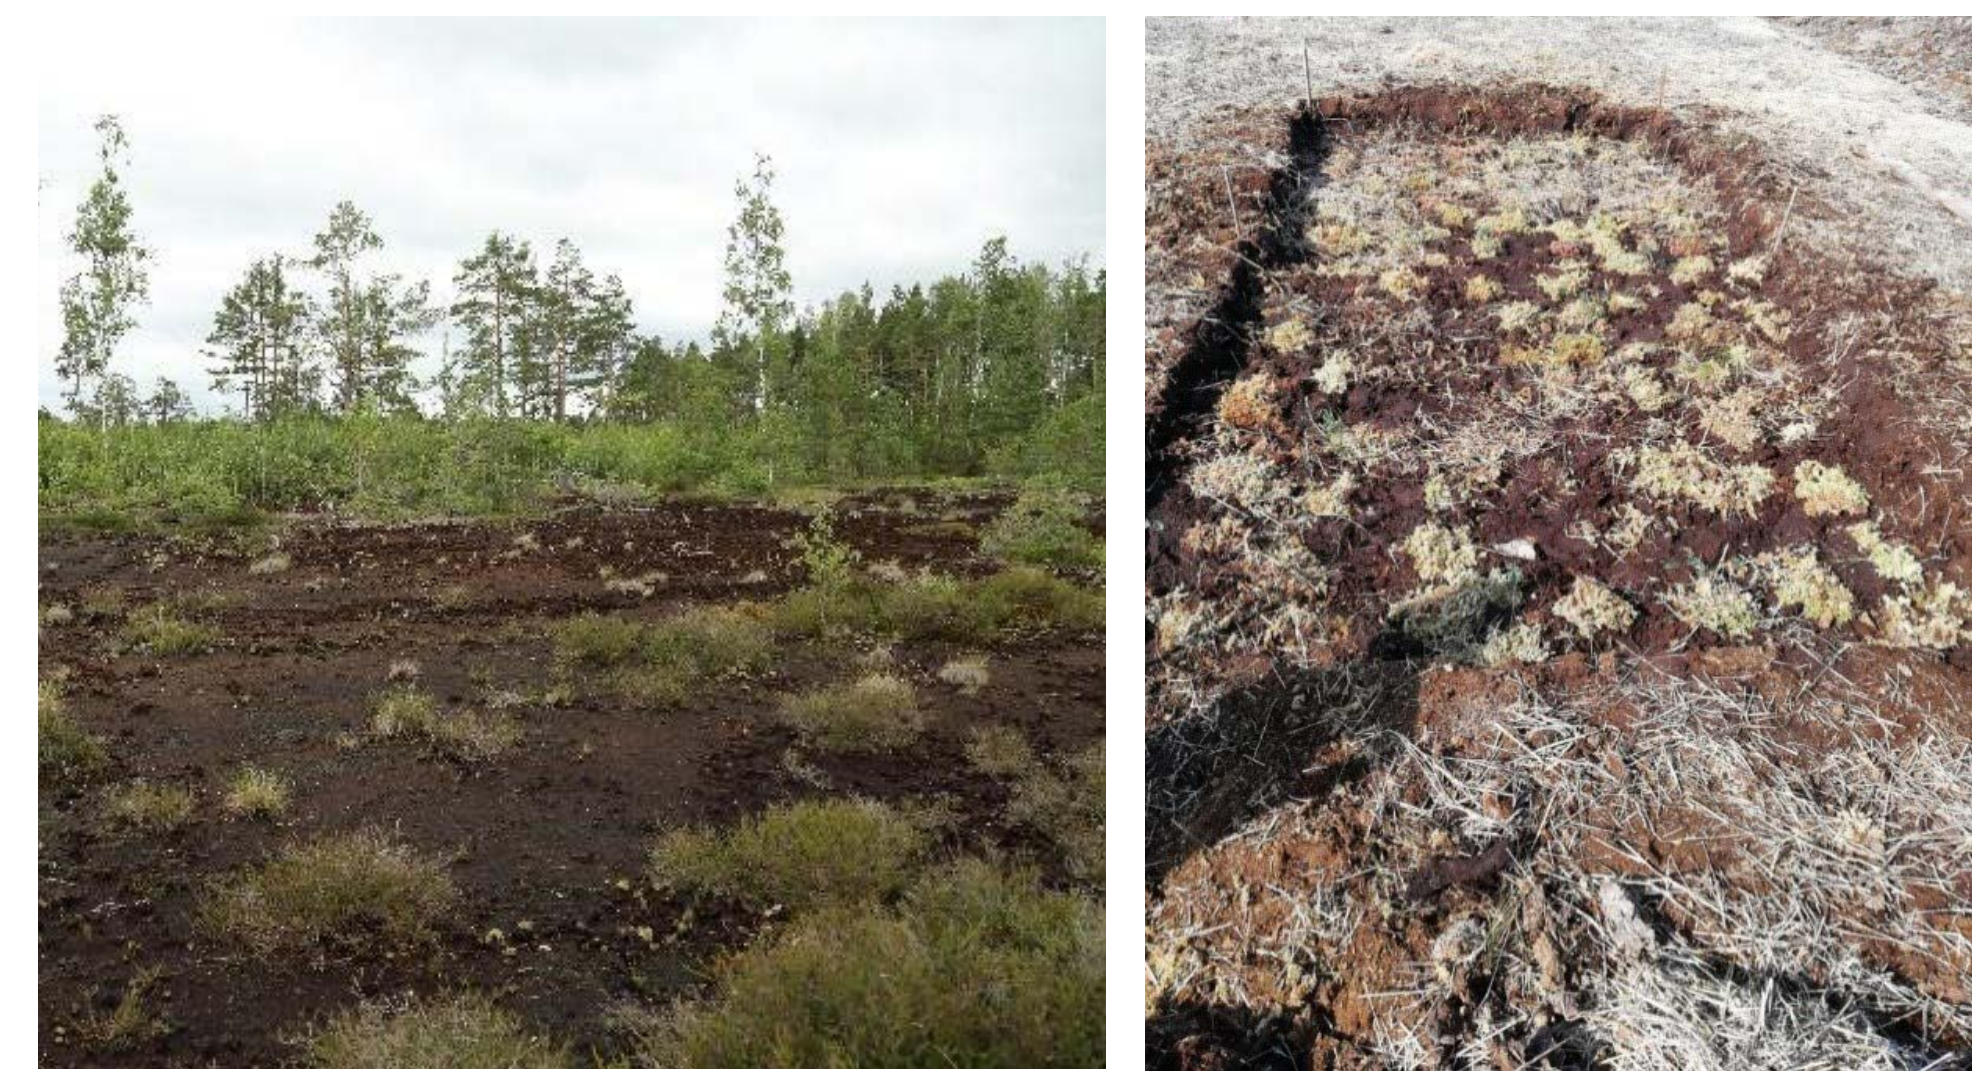
Figure 3. Demo site before the renaturalisation in 2016. Photo: M. Pakalne.

The LIFE REstore project's renaturalization demo area is located on the northeastern edge of Ķemeri mire (Figure 1, 2). Renovation by planting sphagnum and other high mire plants has been carried out at the site of peat extraction, but the vegetation of the mire has not been restored (Figure 3) for more than 30 years (since the beginning of the 1980s, when peat extraction was stopped).

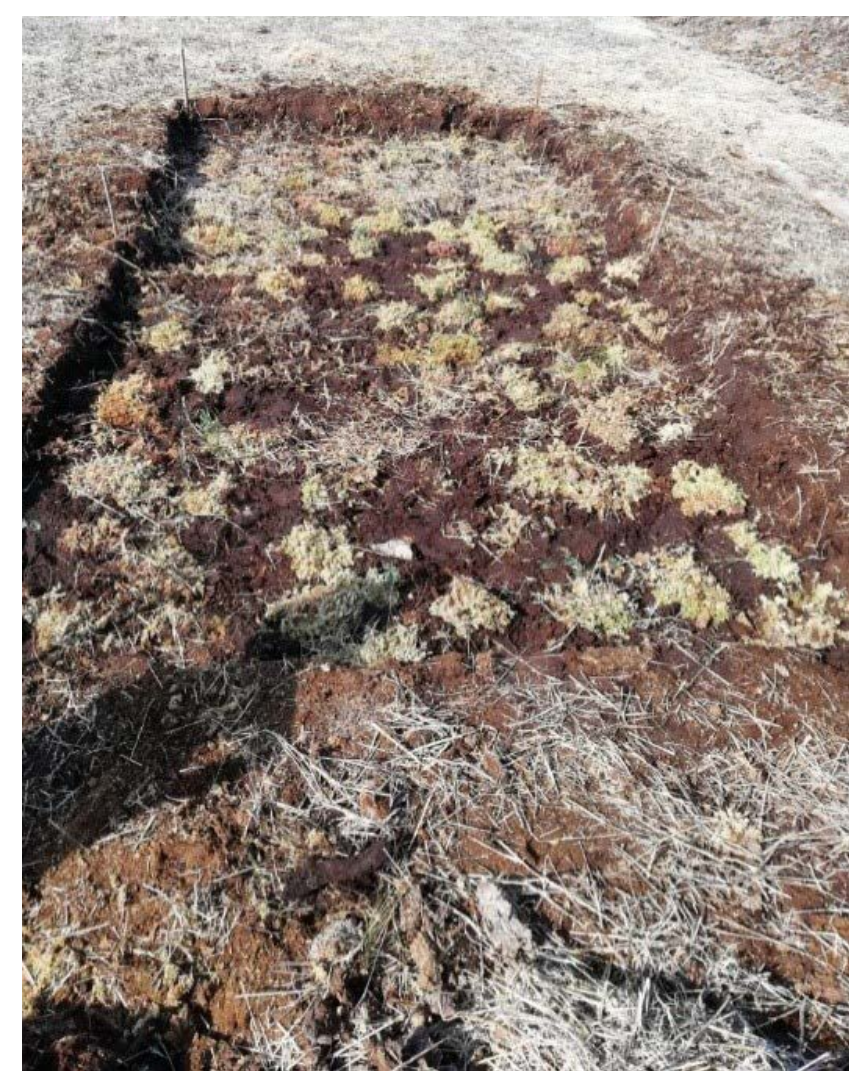
Figure 7. Sphagnum planting in autumn. Photo: M. Pakalne.

In autumn of 2018, Sphagnum planting experiment was supplemented with a small terrace-shape planting plot. Two 2 x 2 m experimental plots were established at various depths (0.30 m and 0.15 m) (Figure 4, Figure 7), after removing the top layer of peat so that the surface to be planted was close to the groundwater table.

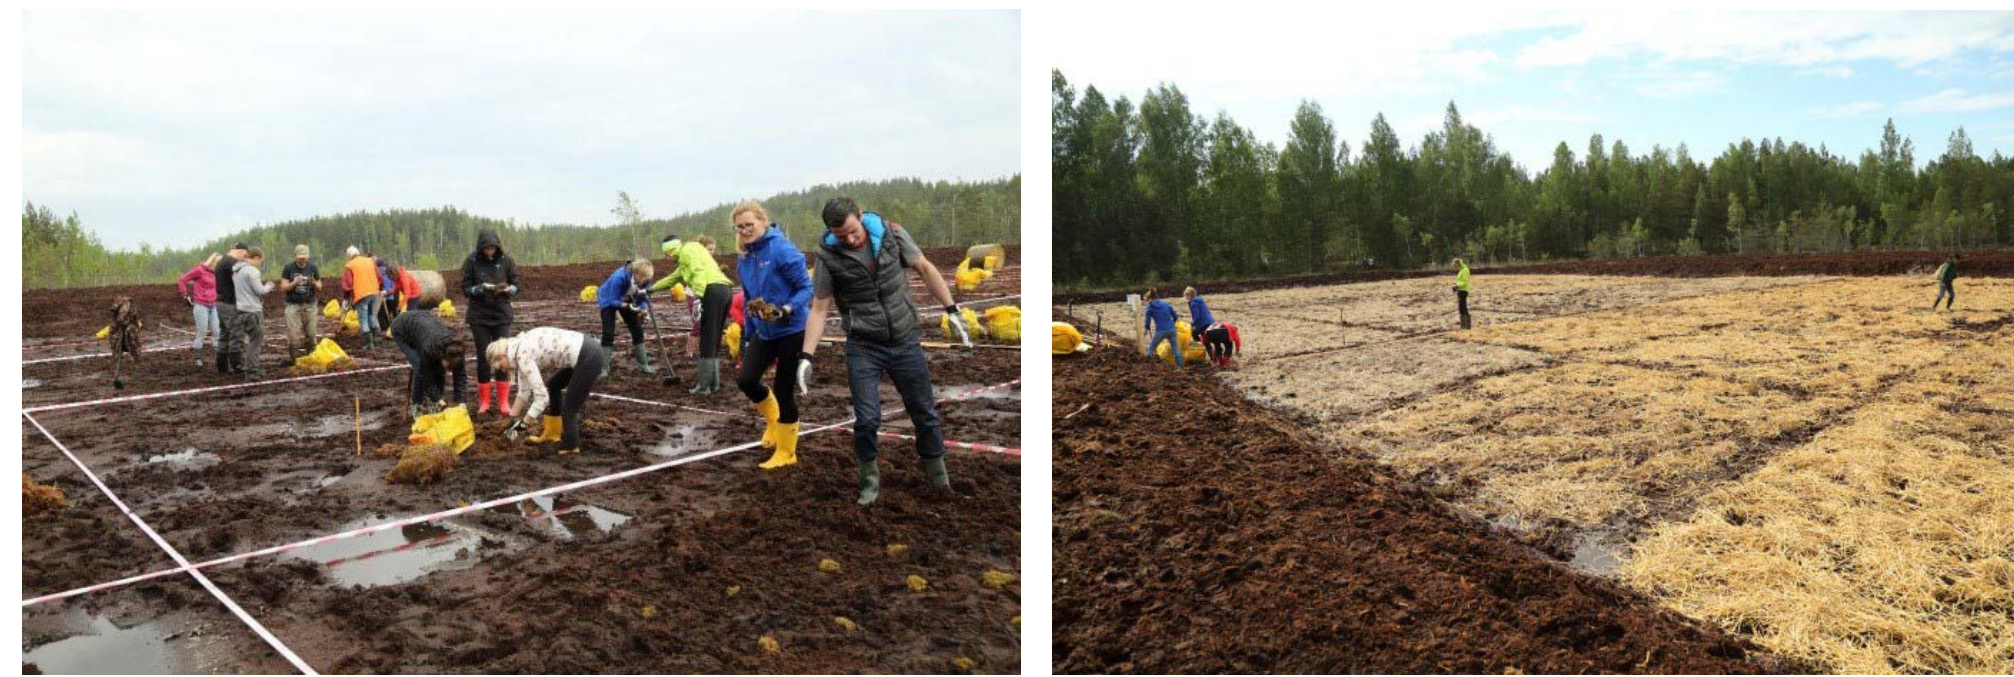
Figure 6. Sphagnum planting. Photo: M. Pakalne.

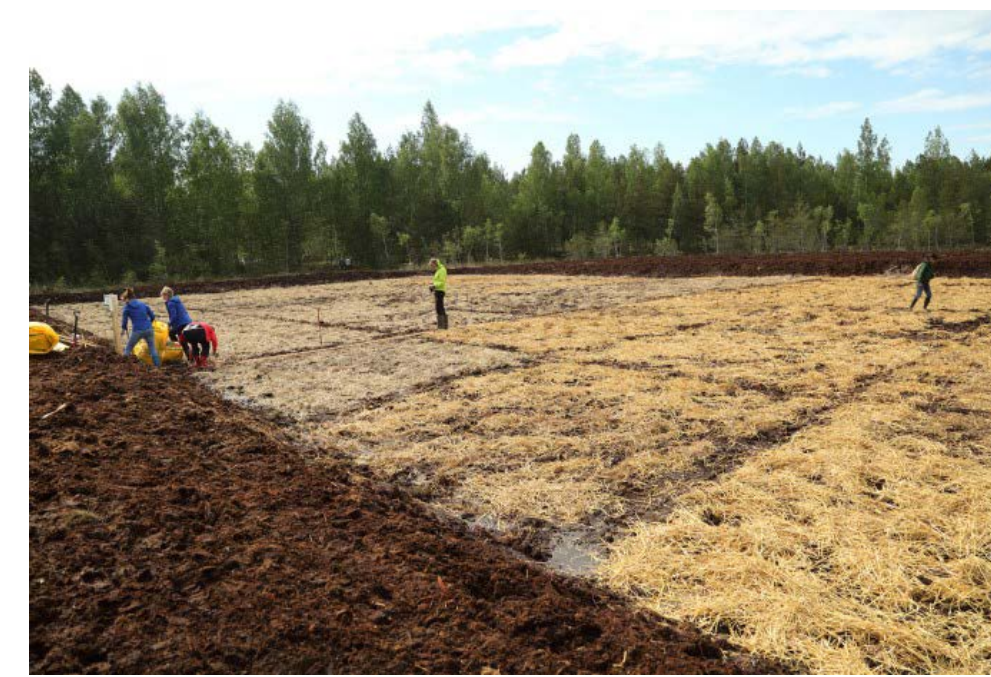
Figure 7. Straw cover created after Sphagnum planting. Photo: M. Pakalne.

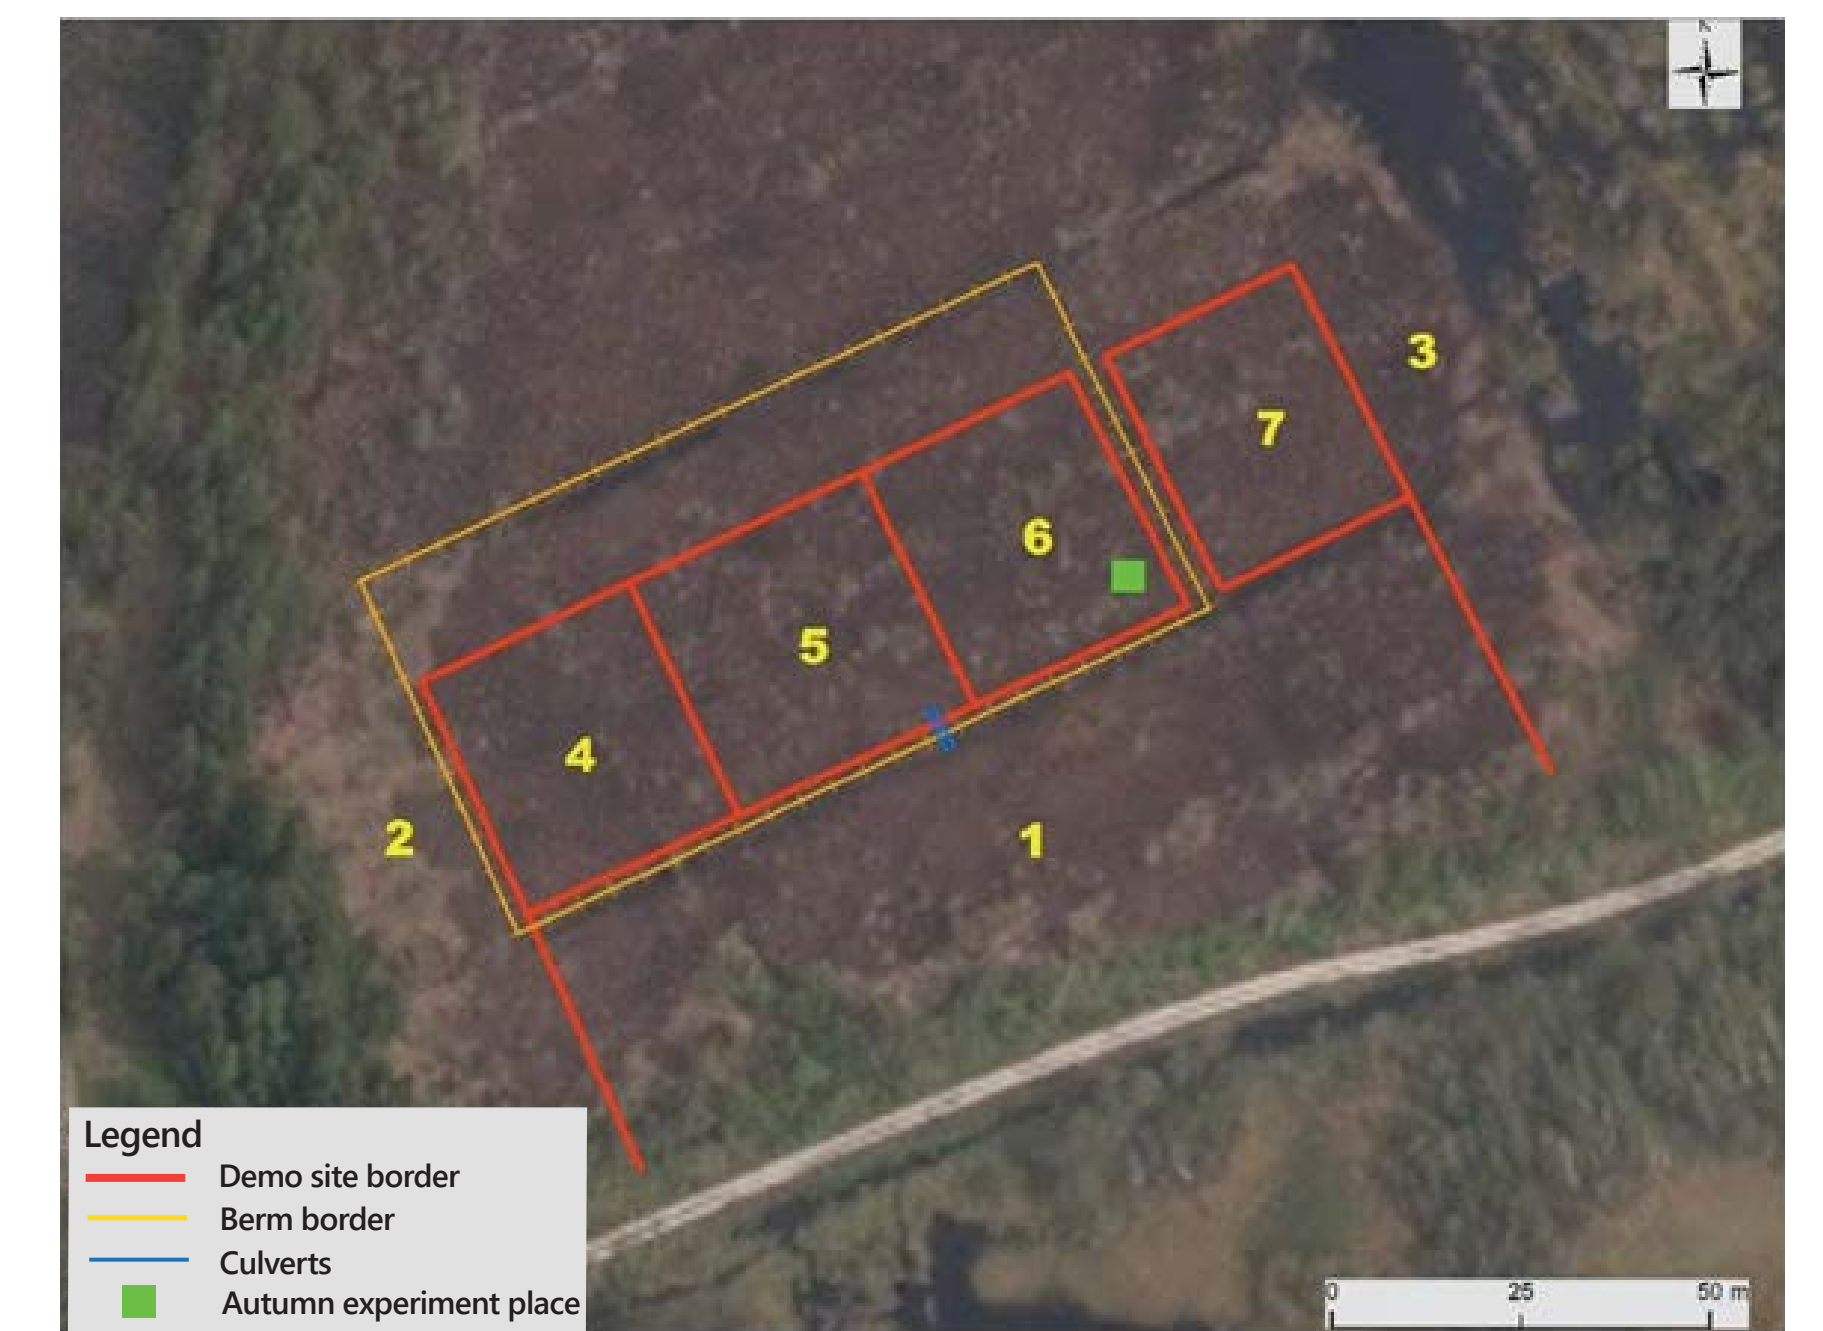
Figure 4. Performed works, location of experimental plots and planted species in demo site. Map prepared by A. Rudusāne, using 5th cycle orthophoto map, 1:10 000. © Latvian Geospatial Information Agency, 2013-2015.

1	Territory where no works were carried out. Vegetation monitoring was started in 2017, and 13 vegetation sampling plots were established.
2	Buffer zone (20 m wide) where no works were carried out.
3	Buffer zone along the ditch with wet peat; border between the demo site and peat quarries. No works were performed.
4	Peat surface was removed and site smoothed. In May 2018, Sphagnum species of hummocks* and bog pools** were planted, and covered with straw.
5	Peat surface was removed and site smoothed. In May 2018, Sphagnum species of hummocks* were planted, and covered with straw.
6	Peat surface was removed and site smoothed. In May 2018, Sphagnum species of hummocks* were planted, together with other bog species (Andromeda palifolia, Drosera spp., Sphagnum species of bog pools**) (up to 30% of total cover), and covered with straw. In September 2018, in two 2 x 2 m plots additional plantings were created after removal of peat surface. Dam of peat and planks was constructed on adjacent field ditch.

7	Planting of unsorted Sphagnum mosses without the removal of peat surface. Covered with straw.

\* Sphagnum species of hummocks: Sphagnum magellanicum, S. fuscum, S. rubellum, \*\* Sphagnum species of bog pools: Sphagnum cuspidatum.

- Excessive vegetation was removed. Field ditch was blocked at the northern edge. Surface was levelled (till 8.60 m a.s.l.) towards northern and southern edges and trapezoidal berms were created. To prevent long-term waterlogging, two culverts (gradient 5%) were located in southern edge of field ditch.
- Demo site was divided into four 30 x 35 m experimental plots where Sphagnum moss were planted. In 3 of 4 plots peat surface was removed and surface was smoothed (Figure 4).

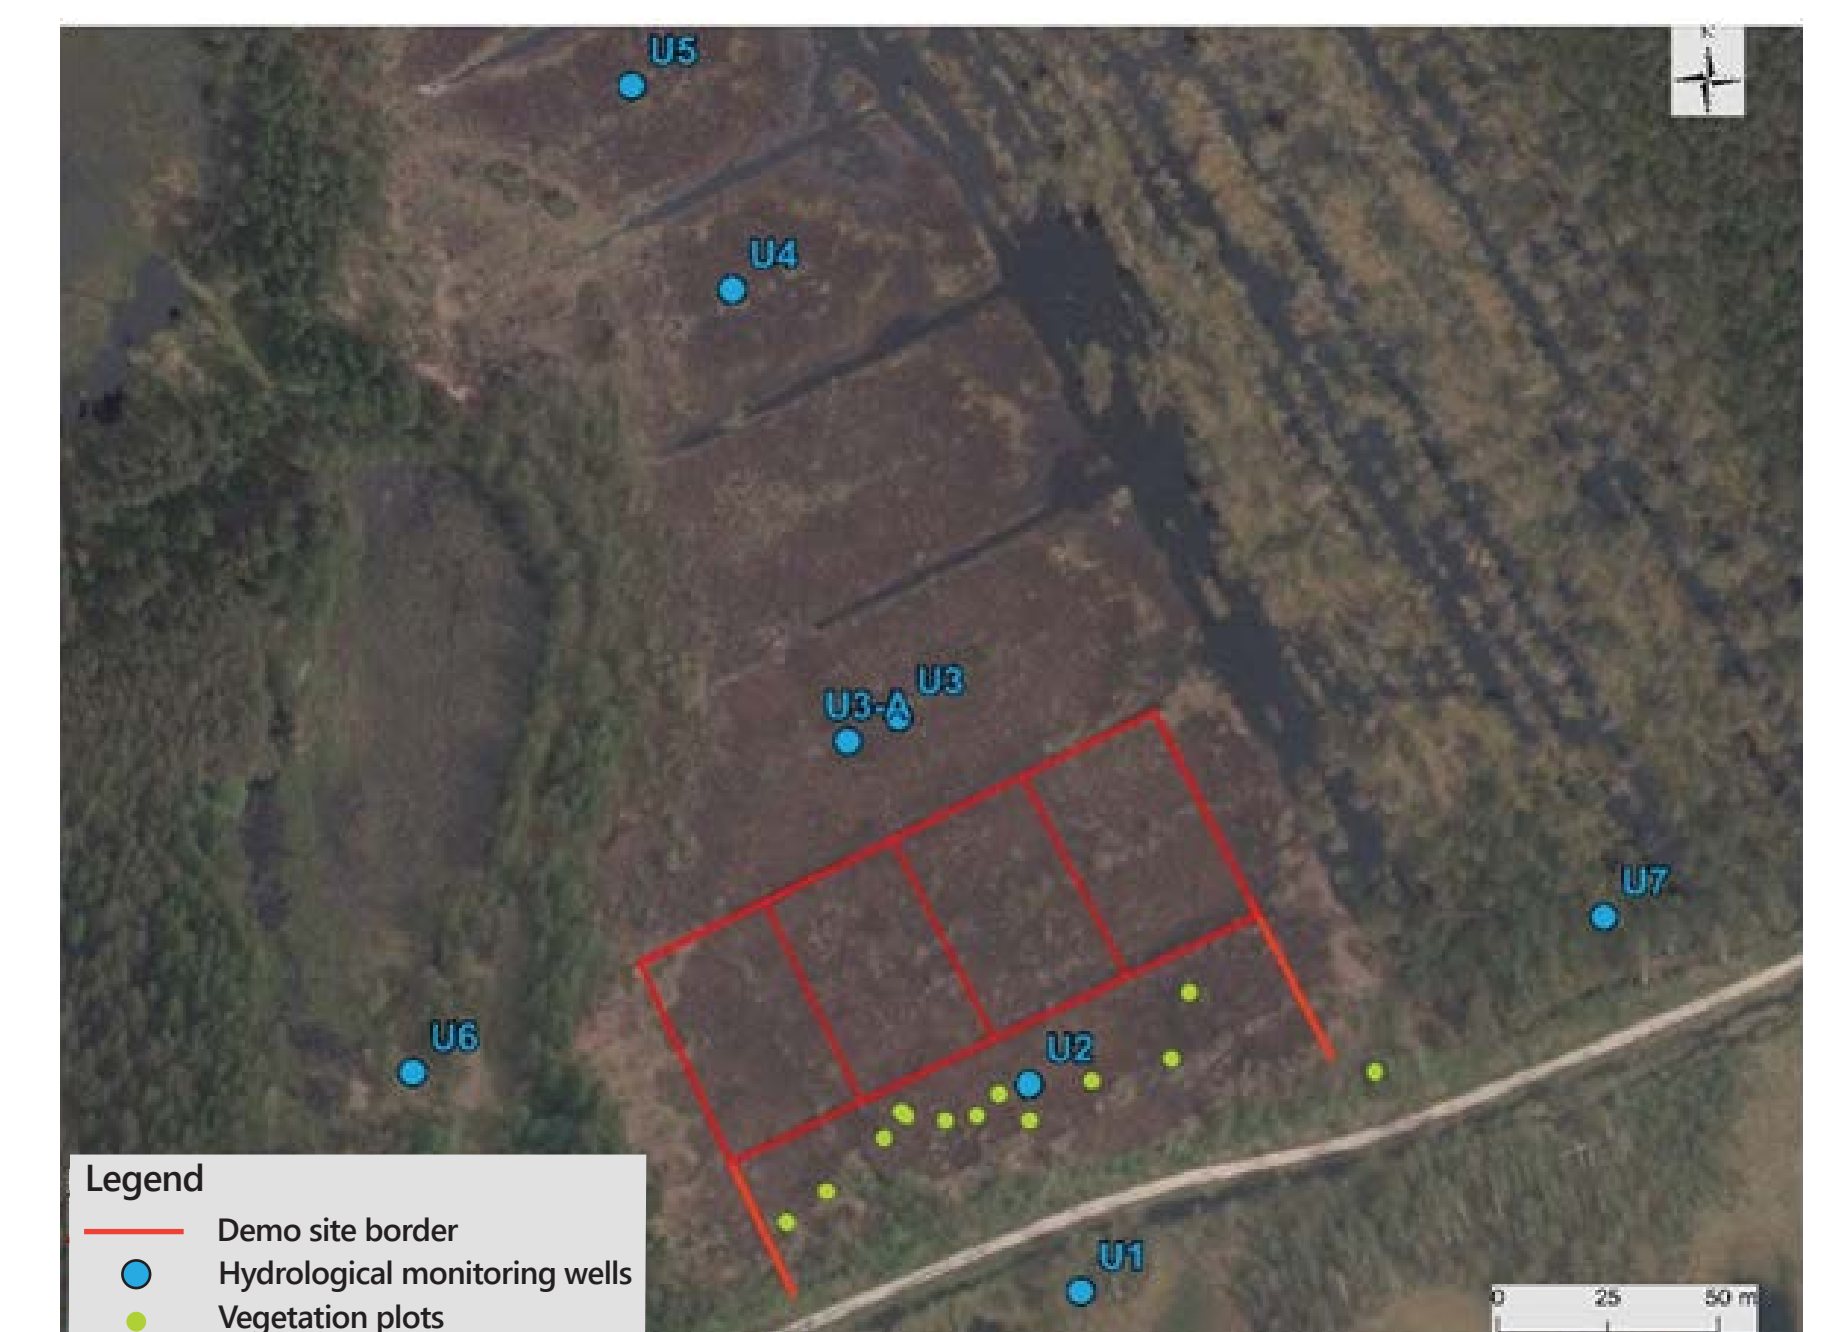
Figure 8. Location of hydrological monitoring wells and vegetation plots in demo site, Ķemeri Mire. Map prepared by A. Rudusāne using the 5th cycle orthophoto map, scale 1:10 000. © Latvian Geospatial Information Agency, 2013-2015.

- Groundwater table was monitored. 8 groundwater observation wells were erected (Figure 8) in demo site and in its immediate vicinity. Hydrological measurements were undertaken manually with Electric Contact Meter Seba KLL Mini, 10m.
- In 2017, 13 permanent vegetation plots were established in the buffer zone of the demo site, before the Sphagnum planting. This will provide a possibility to compare the vegetation development in Sphagnum planting plot with the areas where peat surface was not removed and Sphagnum mosses were not planted.

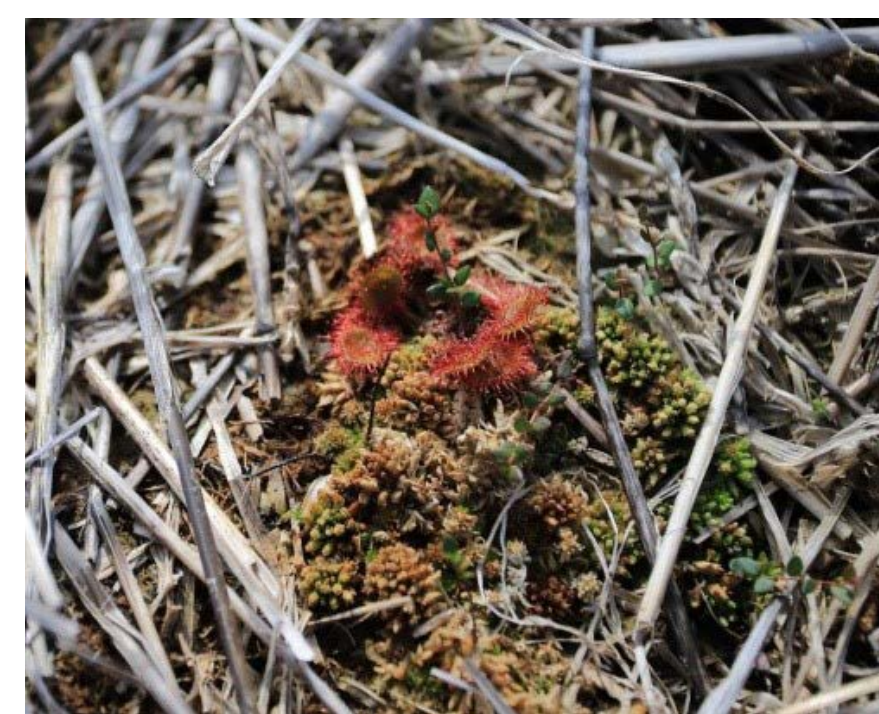
Figure 10. Characteristic species of raised bogs, Sphagnum magellanicum, Drosera rotundifolia, Oxycoccus palustris established below the straw cover. September 2018. Photo: M. Pakalne.

- In autumn 2018, it was observed that all species of Sphagnum (Sphagnum magellanicum, S. fuscum, S. rubellum, S. cuspidatum) have endured below the cover of straw, although in much smaller areas than they were planted (Figure 10, 11). However, less than one year is not sufficient for the objective evaluation of the experiment results.
- Observations from the first year show (Figure 12) that groundwater table in demo site was not sufficient for the survival of planted Sphagnum mosses. No direct correlation with rainfall has been observed. The series of observations reflects a relatively short period of time, therefore a linear relationship was also not expected.

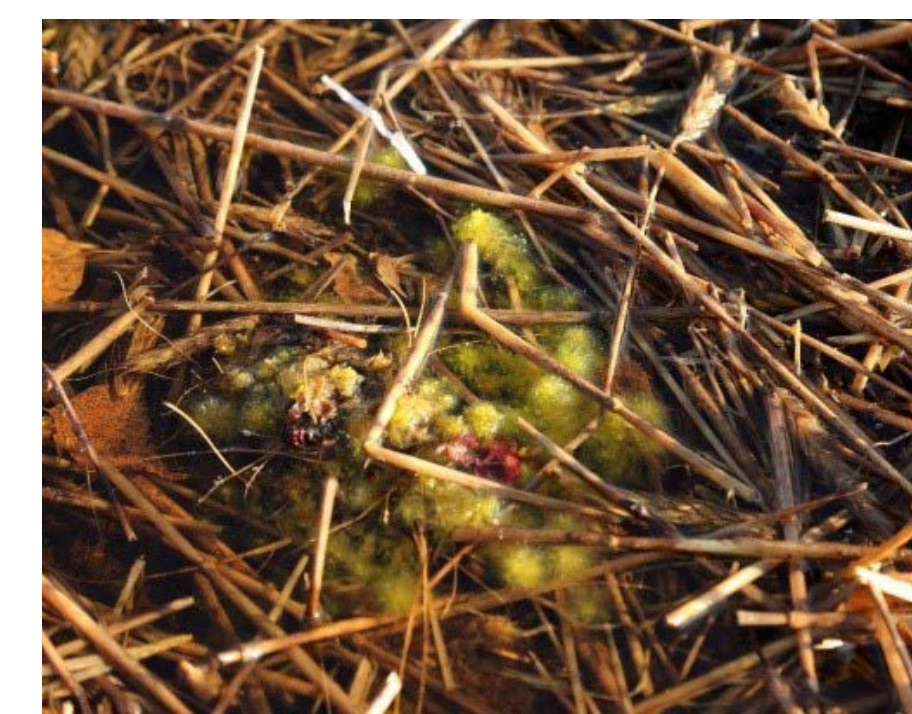
Figure 11. Sphagnum cuspidatum, S. rubellum, Drosera rotundifolia in the lowest places in planting site. September 2018. Photo: M. Pakalne.

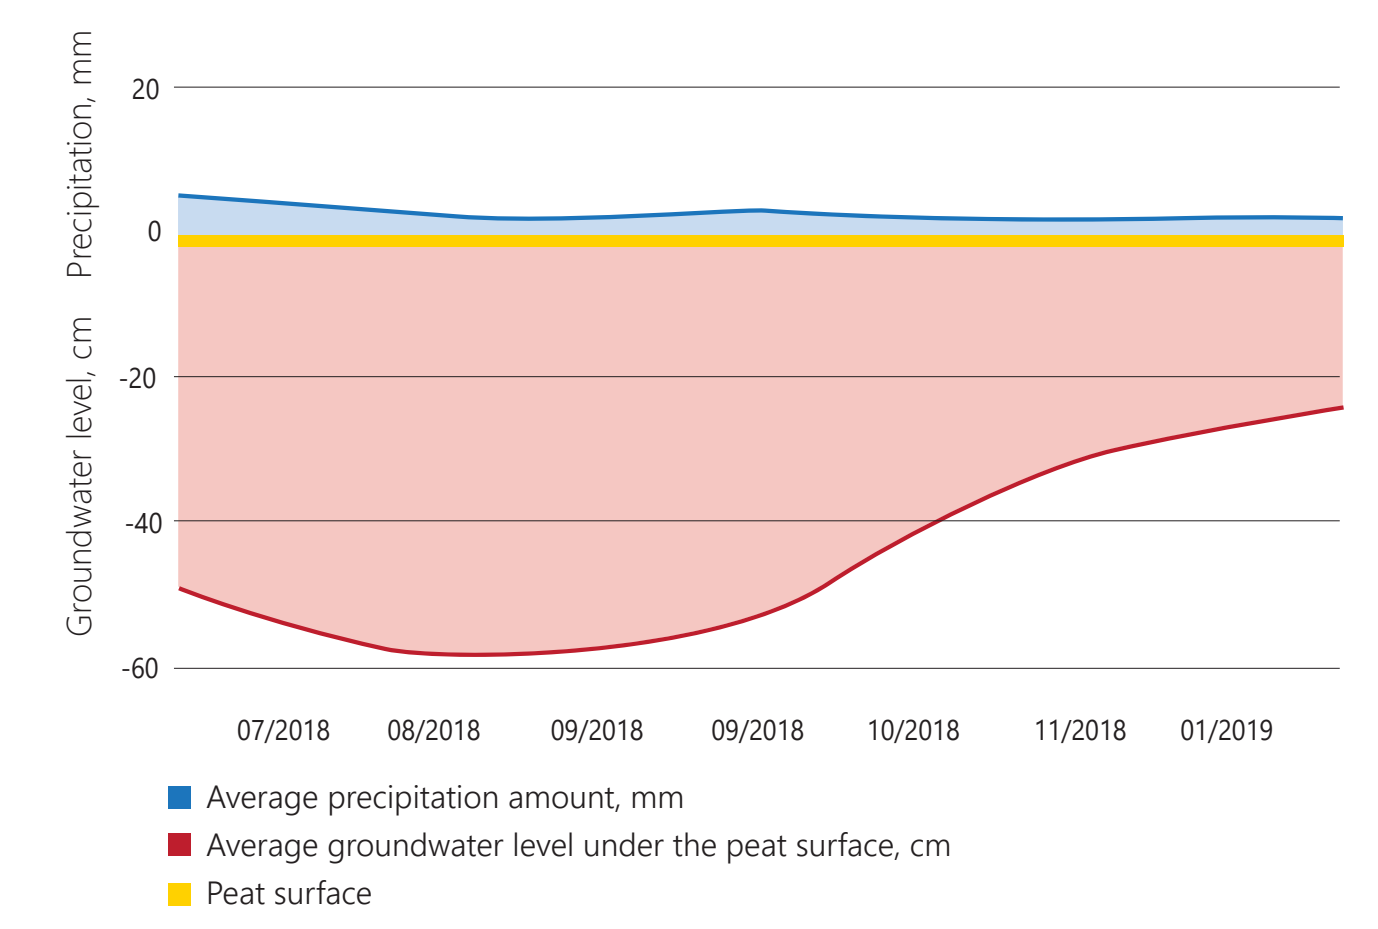
Figure 12. Average groundwater table in relation to average rainfall from July 2018 to February 2019. Authors: Agnese Priede, Agnese Rudusāne.
